D868UV firmware update V1.26 and V2.26

V1.26 and V2.26 Improvements (dated 2018-3-12)

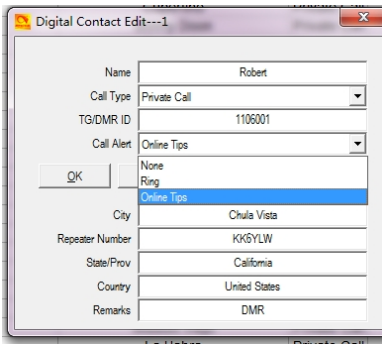
3. Add a Call Alert option in Digital Contact, when you set it to Online Tips, it will perform as below.

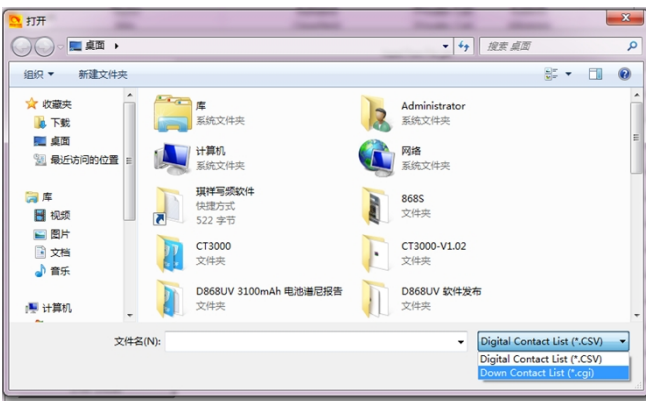
3. D868UV CPS allows importing the digital contact .cgi file download from website directly with changing the file open type to .cgi file. If you change the download data base .cgi file to .csv file for importing purpose, it may cause missing contacts after importing.

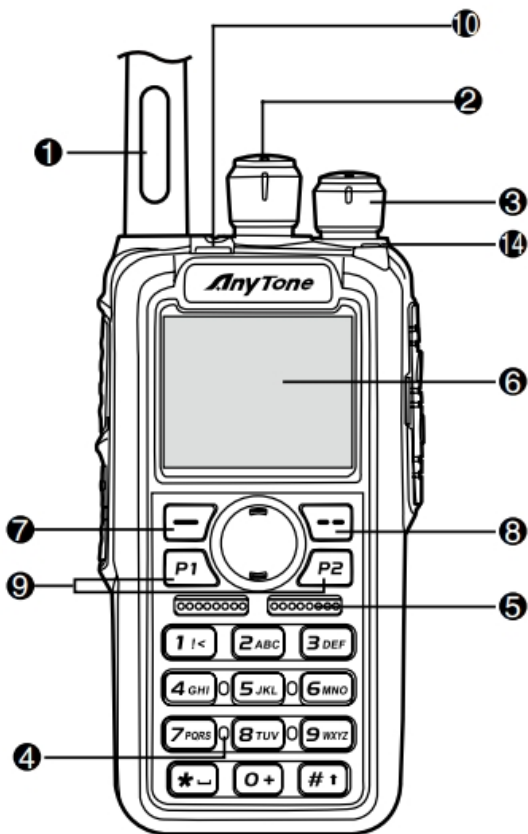
How to know your firmware version

Press 7
